## Technical Evaluation of the Gold King Mine Incident

San Juan County, Colorado

October 2015

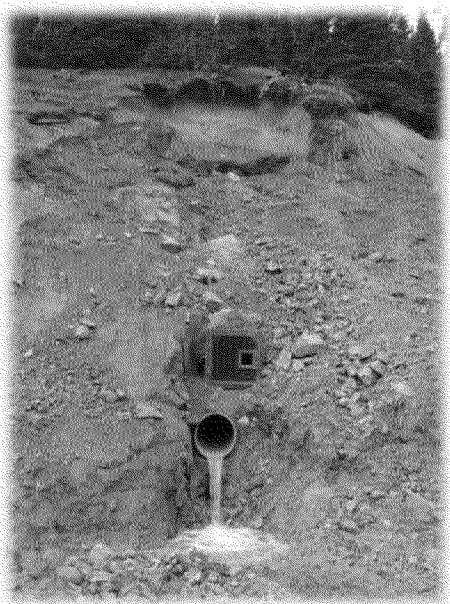
Gold King Level 7 Old Portal Closure

Both Level Seven portals were partially collapsed prior to backfilling in 2009. The Level Seven New Portal required additional fill to remove the unstable fifteen feet of continually collapsing timbered area that remained in front of the complete portal collapse from fifteen feet on. The Level Seven Old Portal also required additional closure in front of the complete portal collapse from thirty feet on. An observation pipe and drainage pipe were placed in the Level Seven Old Portal, but during filling around the pipes, the timbers in the portal collapsed and loose colluvial material completely covered the observation and drainage pipes. The drainage pipe continues to drain at roughly 200 gallons per minute, at the same flow rate as before the collapse. The observation pipe was meant to provide stable access to view the collapse at thirty feet, allowing the landowner and the DRMS to monitor this unstable draining adit, which is arguably one of the worst high quantity, poor water quality draining mines in the State of Colorado. Because of the collapse, DRMS decided to install a well point, driven into the collapse, through the drainage pipe, in an attempt to alleviate concerns about an unstable increase in mine pool head within the Gold King workings. The installed 6 inch perforated steel pipe penetrated approximately 12 feet of collapsed material thought to exist between the original collapse and the end of the drain pipe. The well point was unable to penetrate through any of the original existing collapse in the tunnel.

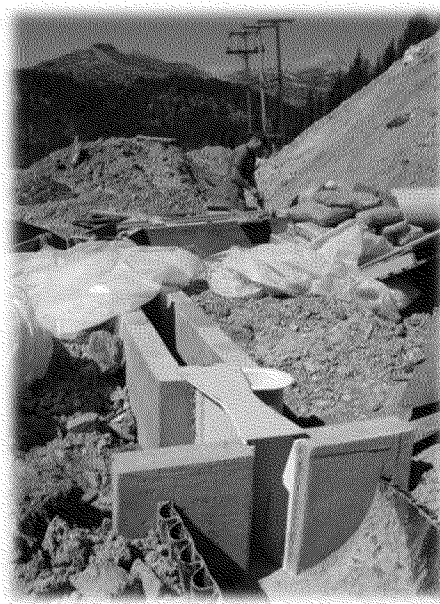
Gold King Level 7 Old Portal with 2" Parshall Flume Installed in Concrete Lined Ditch

A flume was installed at the Level Seven Old Portal as part of the bond revocation reclamation. The two inch Parshall Flume was installed in a concrete lined ditch immediately in front of the HDPE lined ditch. The flume will be used to monitor flow by the landowner and the Animas River Stakeholders Group (ARSG).

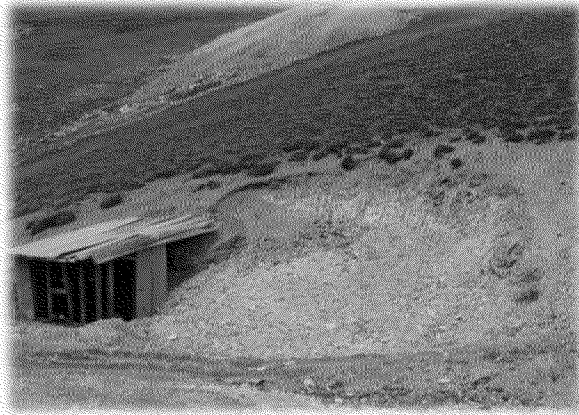
*Number 1 Portal backfilled*

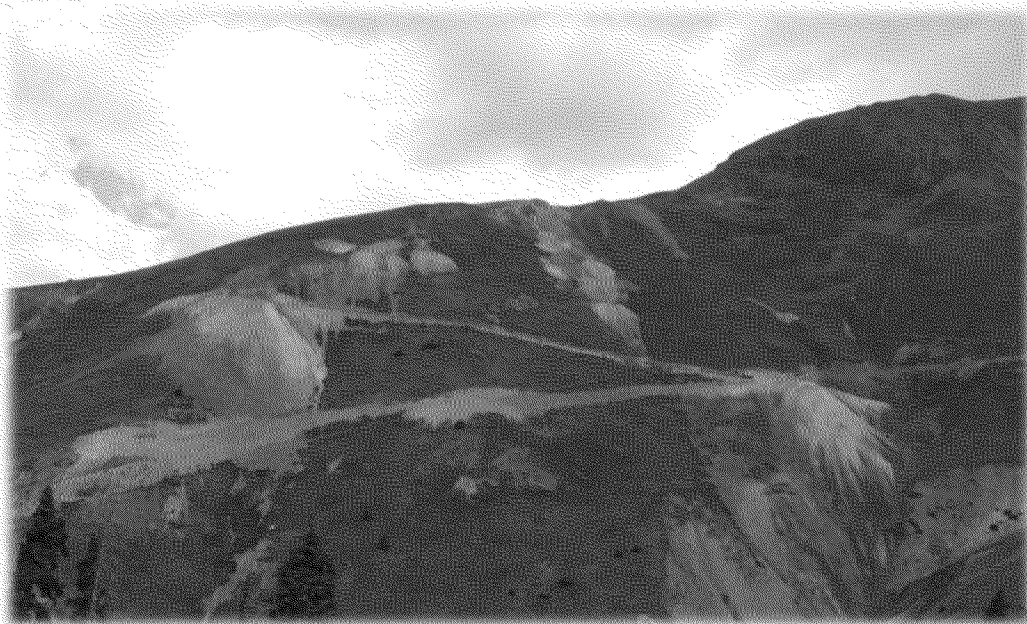
*Sampson Portal, Drill Road, and Number 1 Portal as viewed from access road after reclamation. Drill Road has been re-contoured and revegetated in this photo.*

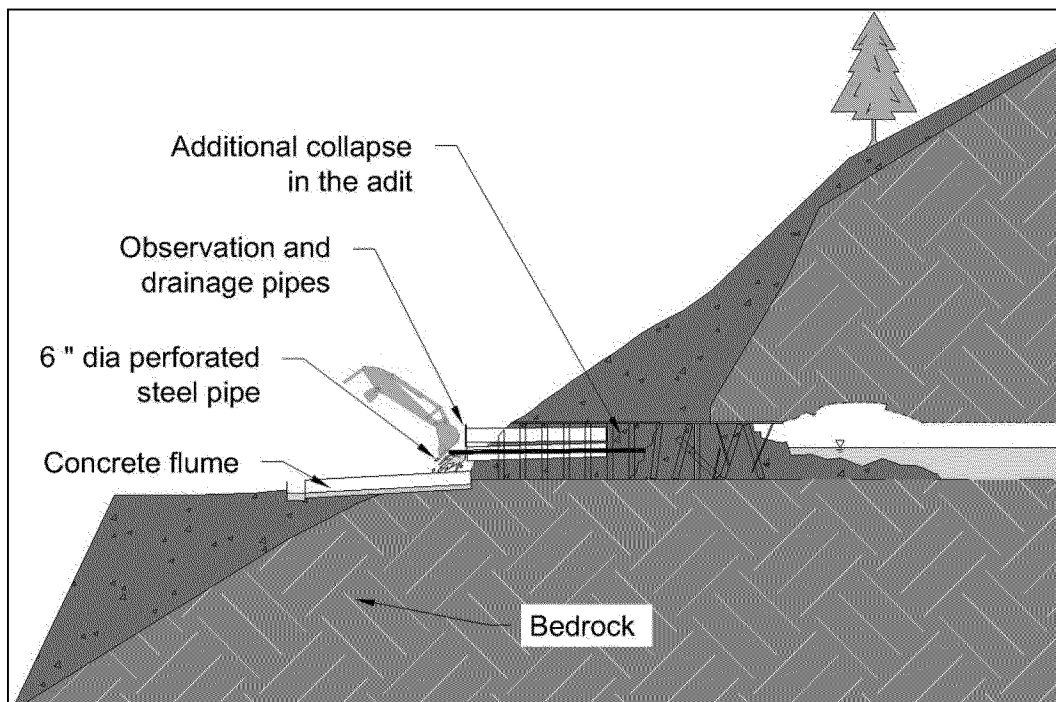
The DRMS stated in the project summary, “A future project at the site may attempt to cooperatively open the Level 7 Old Portal in an effort to alleviate the potential for an unstable increase in mine pool head within the Gold King workings.” Essentially, the closure did not provide adequate drainage and had the potential to blowout.

Figure 21.—Cross-section showing the installation of pipes by DRMS at the Gold King Mine Level 7 New Adit in 2009 (water level as assumed by DRMS) (not to scale).

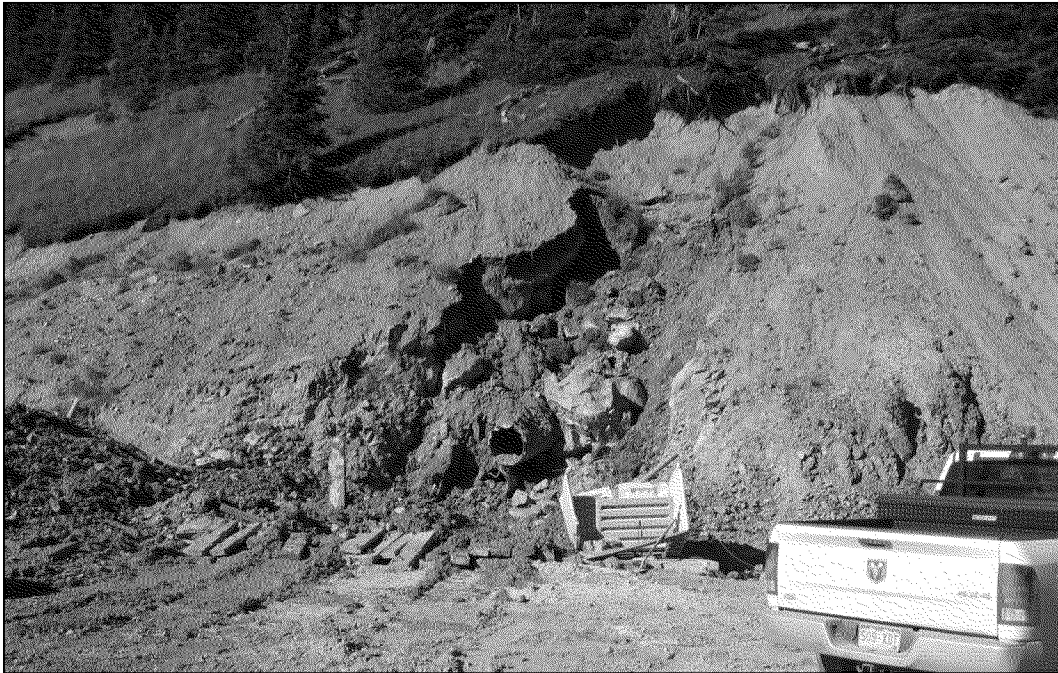
On September 11, 2014, excavations were performed to remove the metal grating and portions of the two pipes installed in 2009. As the excavation progressed down through the fill, seepage appeared (figures 25 through 27). The work stopped when EPA, DRMS, and others observed that in addition to the seepage from the base of the fill, additional seepage was now flowing from higher up on the face of the backfill. Because the excavation had a lip, the seepage ponded at a level equivalent in elevation to about 4 feet below the top of the adit. It was reportedly concluded by those onsite that there was 6 feet of water impounded in the mine (Way, 2014b). A small settling pond was installed at the base of the waste-rock dump to remove sediment from the mine water. The pond was not large enough to treat and settle what was believed to be 6 feet of impounded water. Therefore, the project was put on hold until the following year.

Figure 25.—Photograph showing excavation of the Gold King Mine New Adit portal on September 11, 2014. The metal grating and portions of the upper corrugated HDPE pipe and the lower solid-wall drain pipe have been removed (photograph from EPA project files).

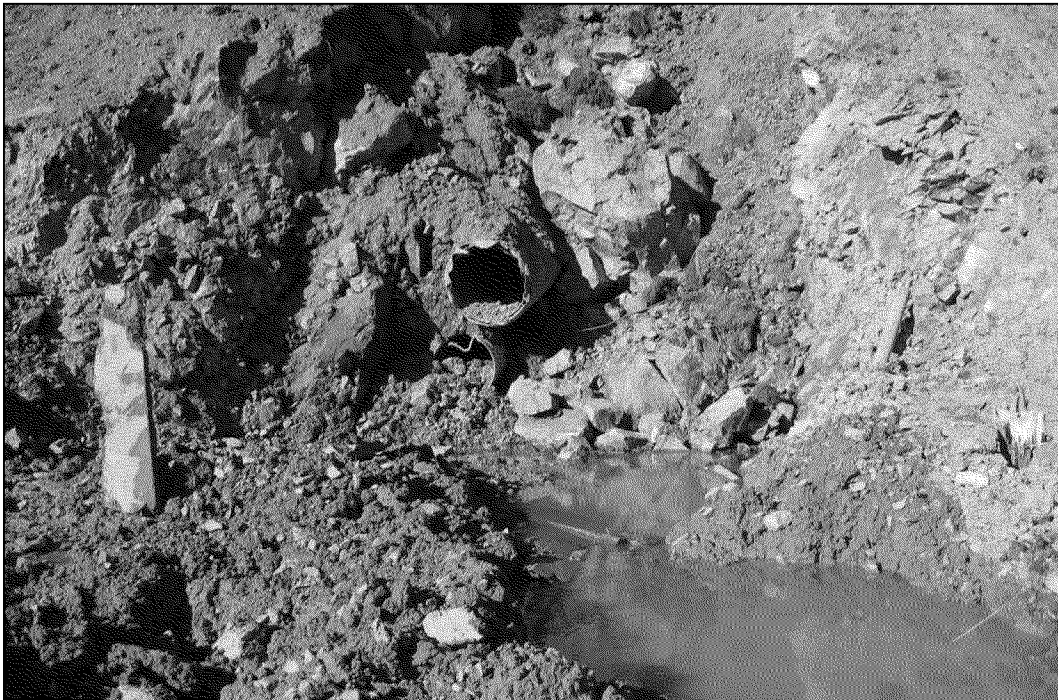
Figure 26.—Photograph showing the excavation of the Gold King Mine New Adit portal on September 11, 2014, taken shortly after the photograph in figure 23 (photograph from EPA project files).

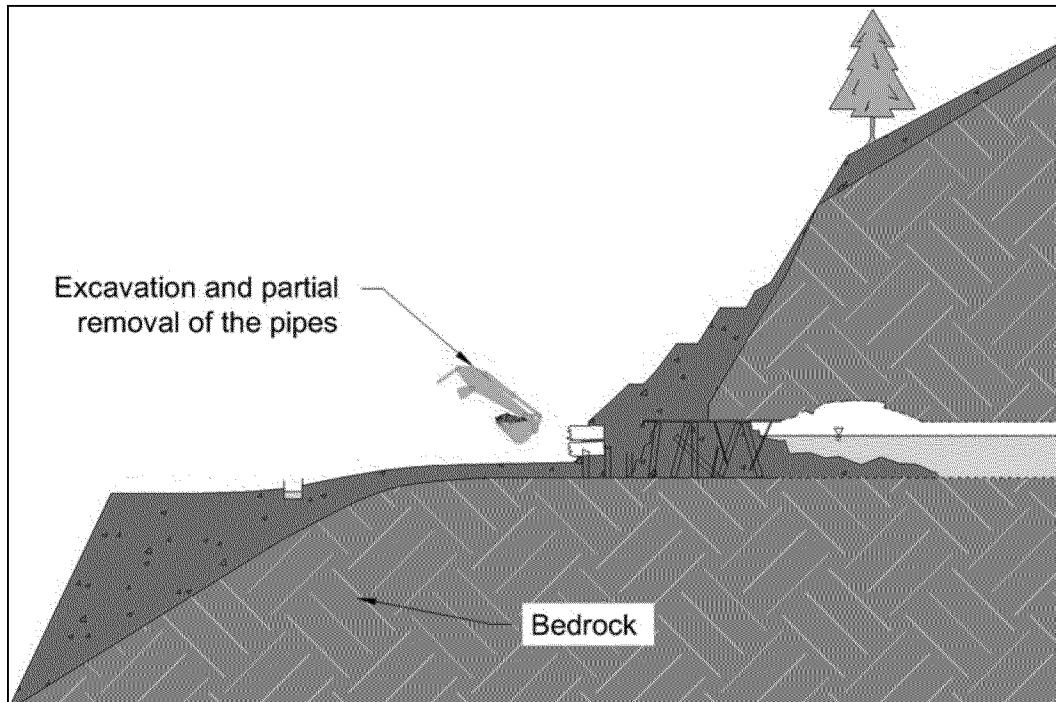
Figure 27.—Cross-section showing the condition of the Gold King Mine New Adit in 2014 (water level as assumed by EPA and DRMS) after the excavation shown in figure 23 was complete (not to scale).

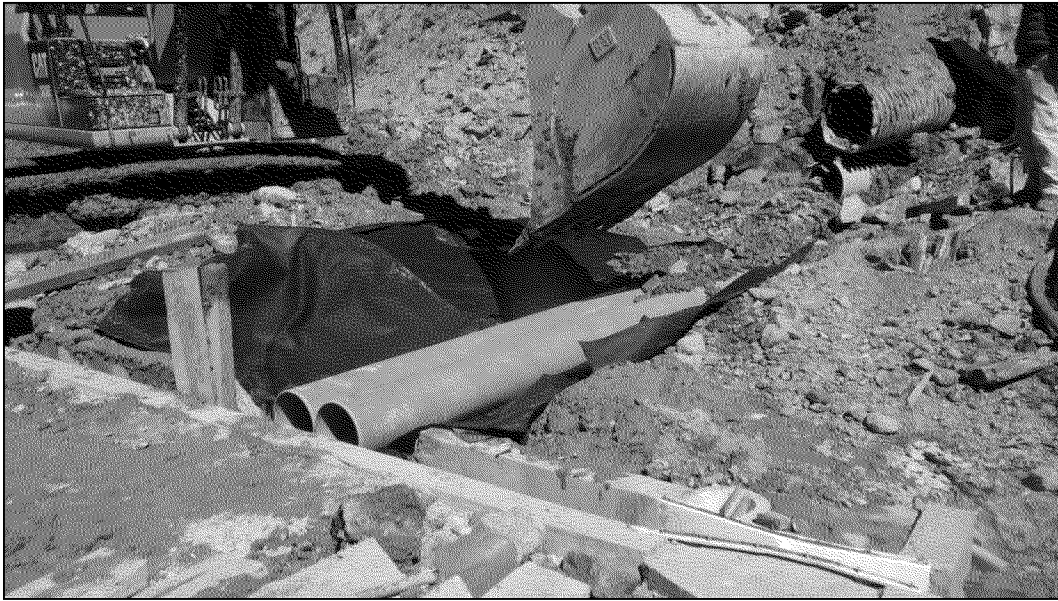
Figure 28.—Photograph taken on September 11, 2014, showing the installation of two new 2-foot-diameter drainage pipes. An entrance slot has been cut into the concrete trough for the pipes to discharge into (photograph from EPA project files).

Because they had torn out most of the drain and observation pipes installed by DRMS in 2009, EPA decided to install two new drain pipes surrounded by gravel and a geotextile as a temporary measure. The new pipes were laid at a different angle than the 2009 installation. The side of the concrete trough had to be cut open to accommodate the new drain pipes (figure 28).

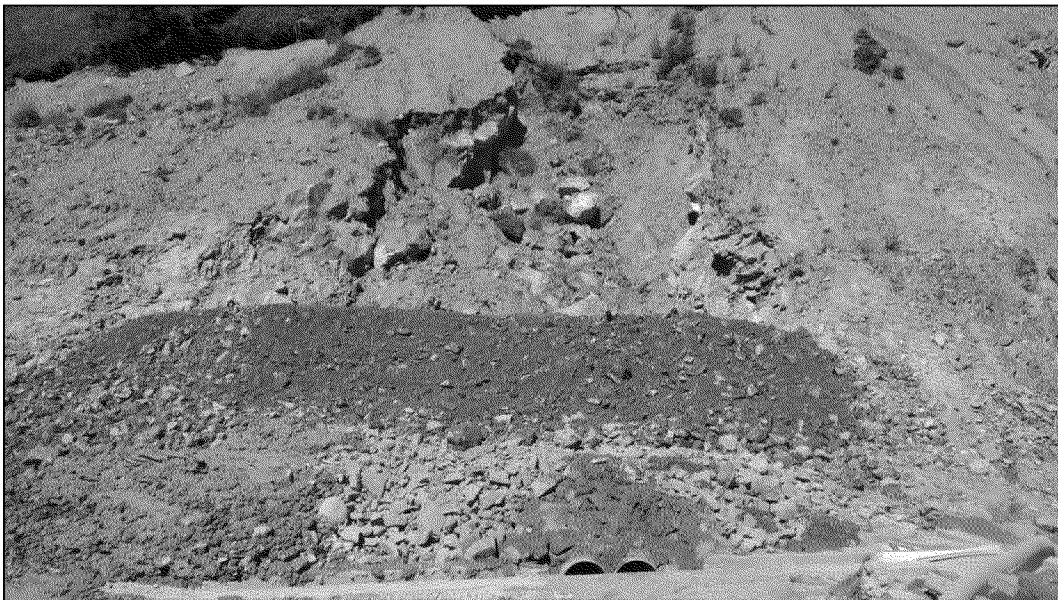
Figure 29.—Gold King Mine Level 7 New Adit as it appeared on September 12, 2014, when EPA completed placing backfill over the two new drain pipes. Note that a steep slope was left in place in the mountainside above the drain pipe installation (photograph from EPA project files).

The pipes were covered with gravel. The geotextile was wrapped around the gravel to prevent infiltration of backfill to maintain a pervious zone around the pipes. The geotextile was then covered with backfill. In order to prevent erosion of the backfill soil into the concrete trough, a layer of fast setting concrete was placed over the backfill slope adjacent to the trough (figures 29 and 30).

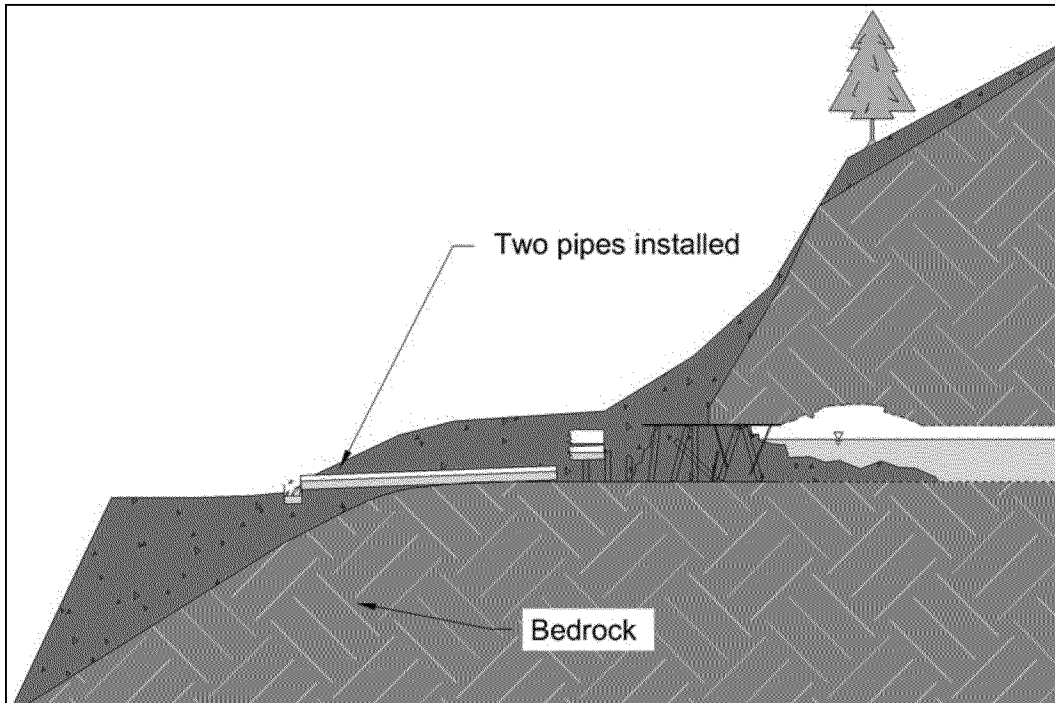
Figure 30.—Cross-section showing the condition of the Gold King Mine Level 7 New Adit in 2014 (water level as assumed by EPA and DRMS), after the installation of the two drain pipes and backfill cover (not to scale).

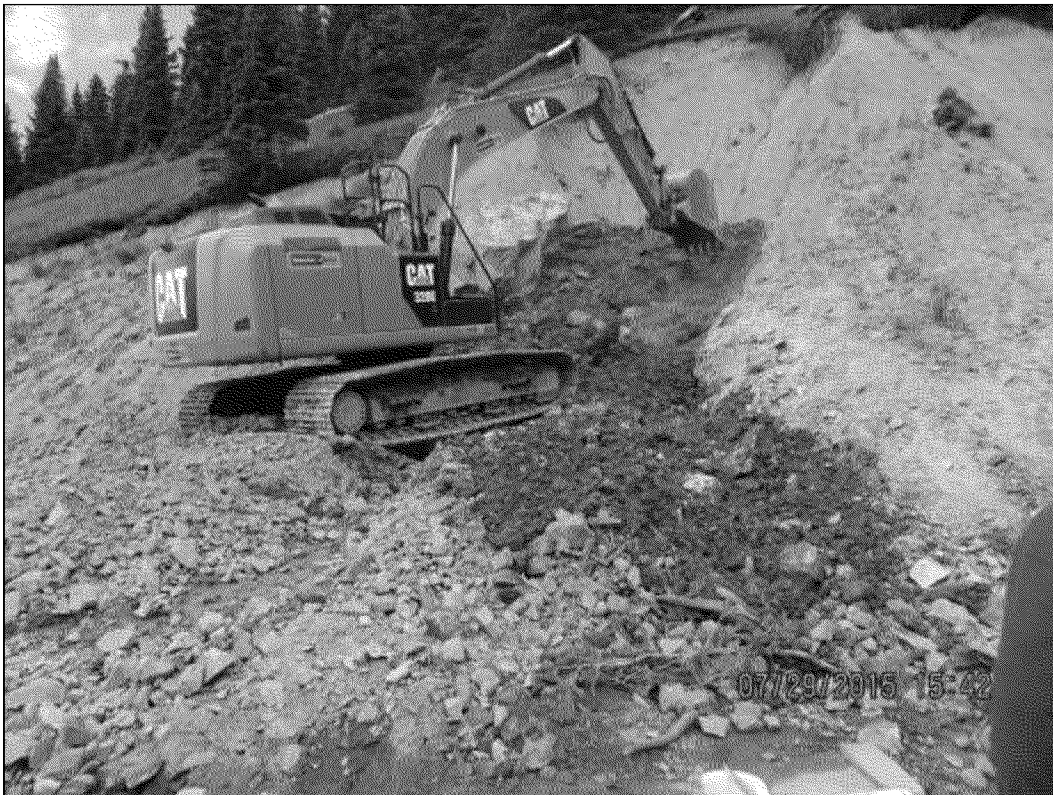
On July 29, 2015, some of the debris that had sluffed down over the winter was excavated from the portal area, and the ends of the pipes were exposed (figure 36). On July 31, 2015, work was begun putting together a manifold piping system that could be used to provide water filtration for the anticipated pump-down of the Gold King Mine.

Figure 36.—Photograph taken on July 29, 2015, showing initial excavation work at the Gold King Mine Level 7 New Adit that was performed to remove the additional accumulation of debris from the eroding slope above the adit (photograph from EPA project files).

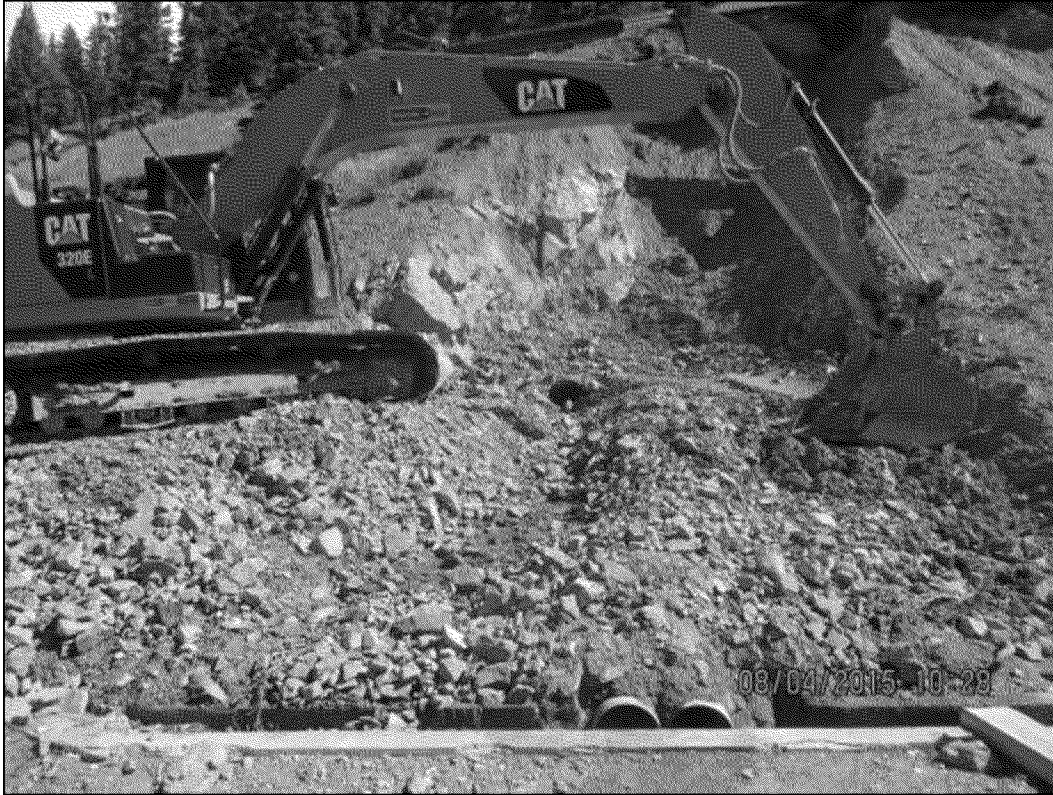
On August 4, 2015, a representative from DRMS was onsite and viewed conditions at the adit. EPA began excavation to examine conditions close to the mine opening similar to what had been done in 2014 (figure 37).

Figure 37.—Photograph showing additional excavation at the Gold King Mine Level 7 New Adit at 10:28 a.m. August 4, 2015 (photograph from EPA project files).

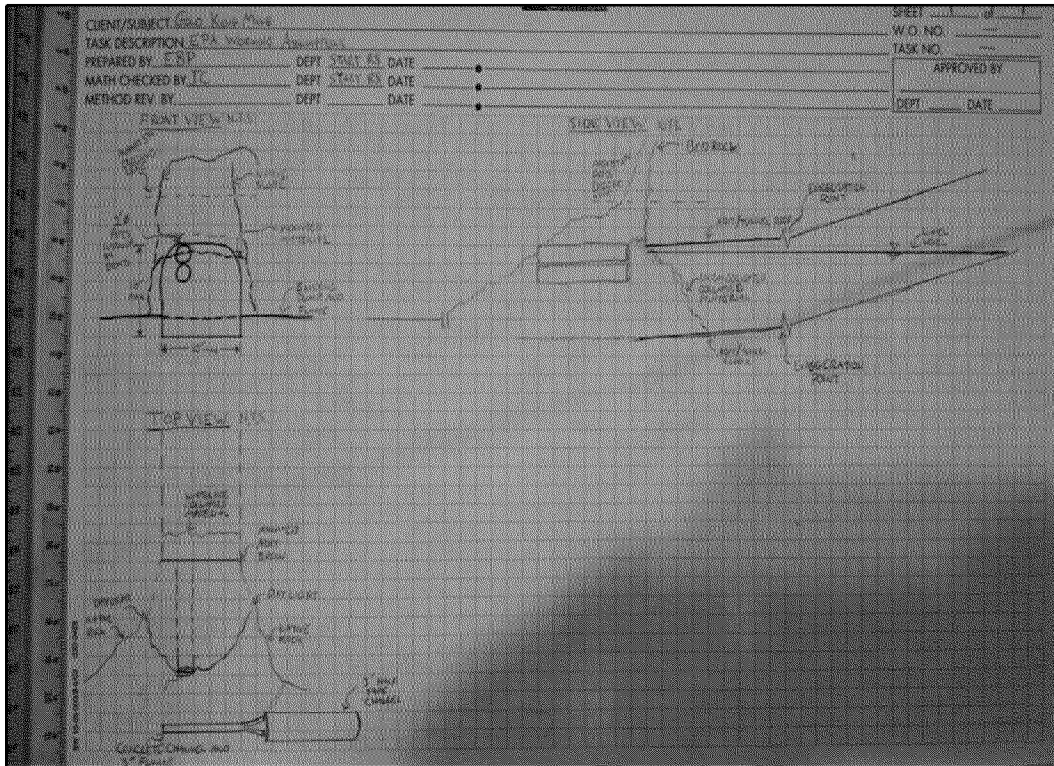
Figure 39 shows a sketch of the plan to open the Gold King Mine Level 7 New Adit portal. To provide a margin of safety, the plan assumes the water was more than 5 feet deep on the upstream side of the blockage, but still below the adit roof.

Figure 39.—Photograph showing the sketch used by EPA to illustrate the conditions at the Gold King Mine Level 7 New Adit portal (photograph from EPA project files).

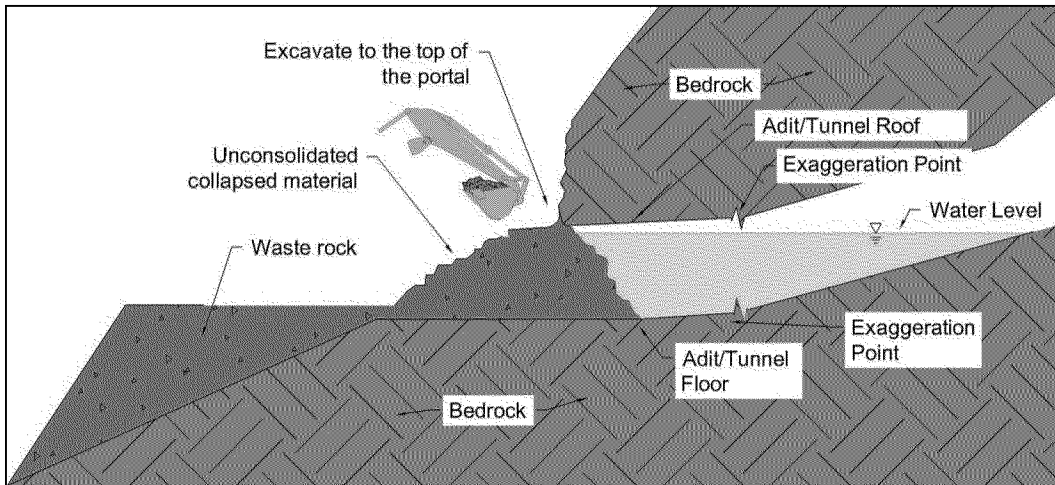
A key aspect of their plan was to only excavate fill lying above the assumed top of the water inside the adit. This method would leave in place the fill holding back the water (figure 41). The next step would push a steel pipe called a “stinger” through the top of the fill to gain access to the mine pool (figures 42 and 43).

Figure 41.—Cross-section illustration showing step 1, the initial excavation to remove the drain pipes and backfill and then carefully excavate the collapsed material to expose the bedrock in the slope above the adit (not to scale).

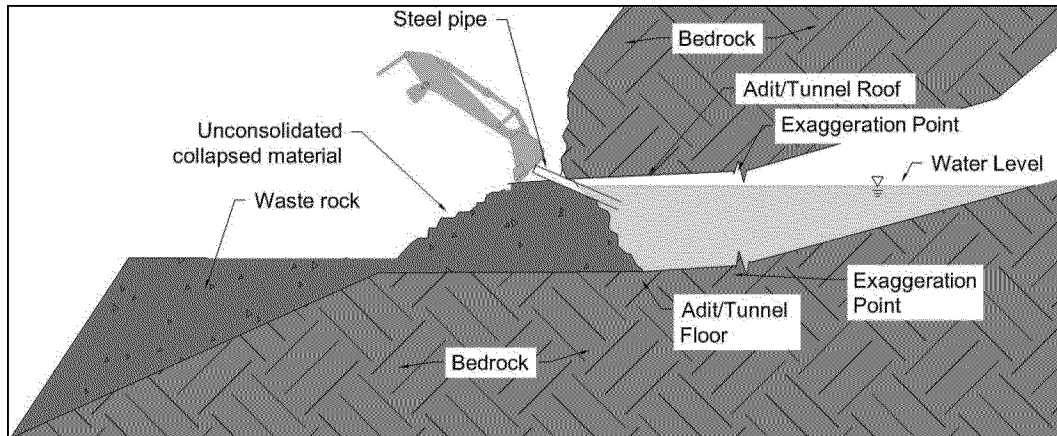
Figure 43.—Cross-section illustration showing step 3 of the plan (not to scale). With the steel pipe fully inserted, contact is made with the water impounded inside the mine.

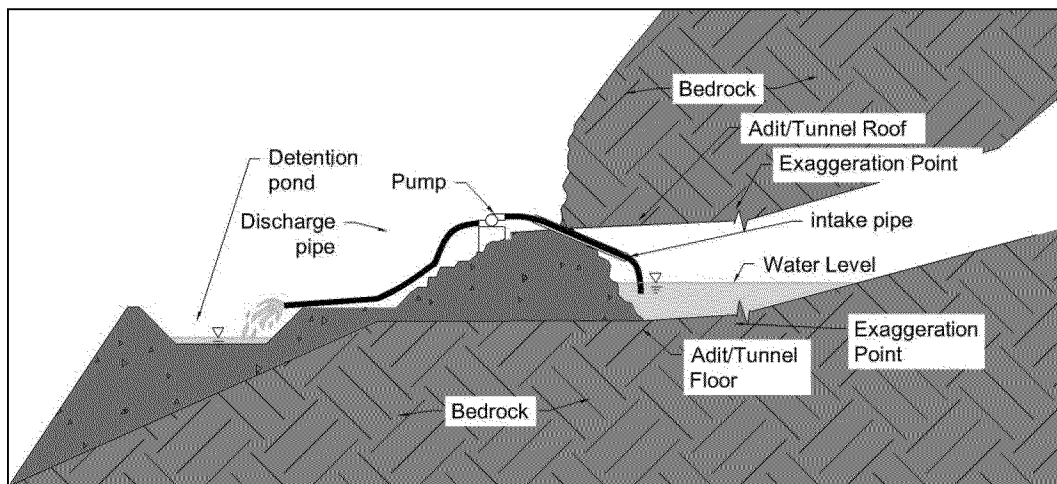
Figure 44.—Cross-section illustration showing step 4 of the plan (not to scale). An intake hose from a pump is inserted into the steel pipe. The pump discharge is taken to a small pond constructed on the waste rock dump. Water from the adit is pumped down. Not shown on this illustration is that the water in the small pond would be continuously removed by another pump and sent to treatment elsewhere on the site.

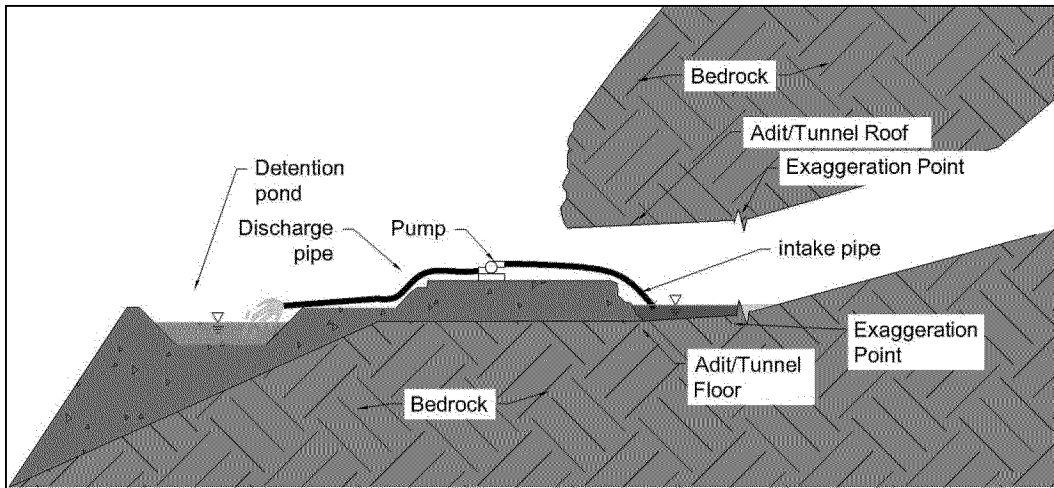
Figure 45.—Cross-section illustration showing step 5 of the plan (not to scale). As the water inside the mine is drawn down by pumping, additional fill from the blockage is excavated and the pump is repositioned to a lower level on the remaining fill. This step is repeated until all the impounded water and the remaining fill is removed; this will establish access to an open adit with the flow freely draining out.

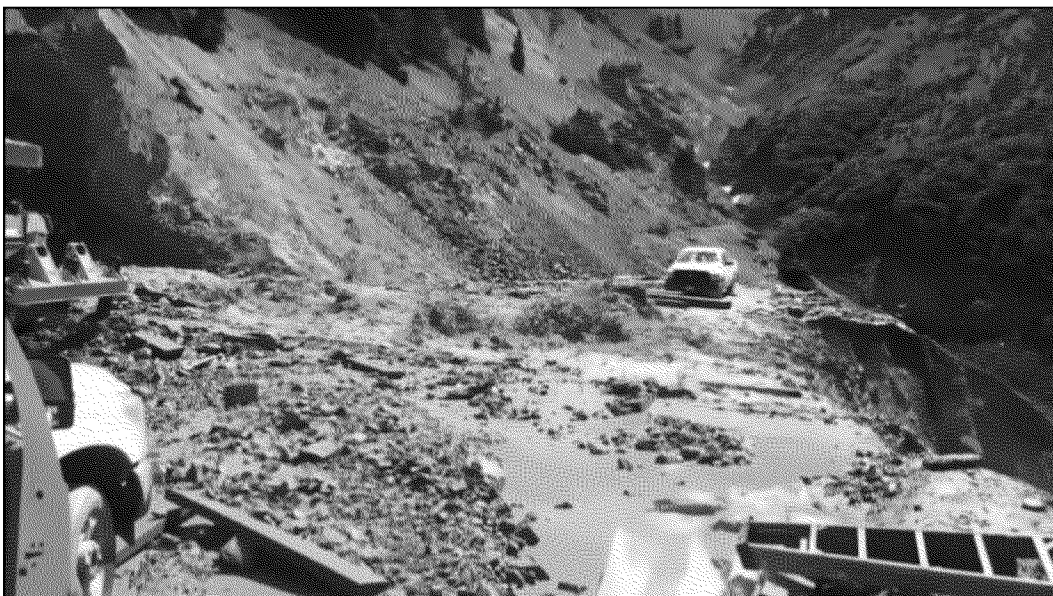
Figure 54.—Photograph showing the peak outflow from the blowout. The waste-rock dump is eroding on the right side of the photograph (still frame extracted from a video taken on August 5, 2015, at approximately 10:57 a.m.).

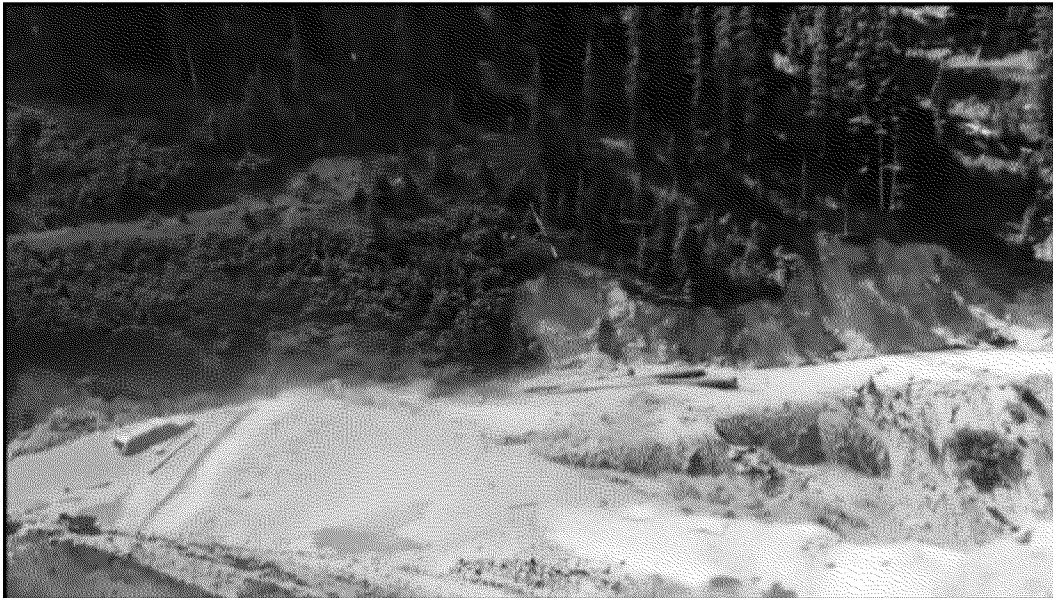
Figure 56.—Photograph showing at left, the inundation of a vehicle parked near the base of the waste-rock dump, and on the right water overwhelming the access road and cascading down into the North Fork of Cement Creek (still frame extracted from a video taken on August 5, 2015, at approximately 10:57 a.m.).

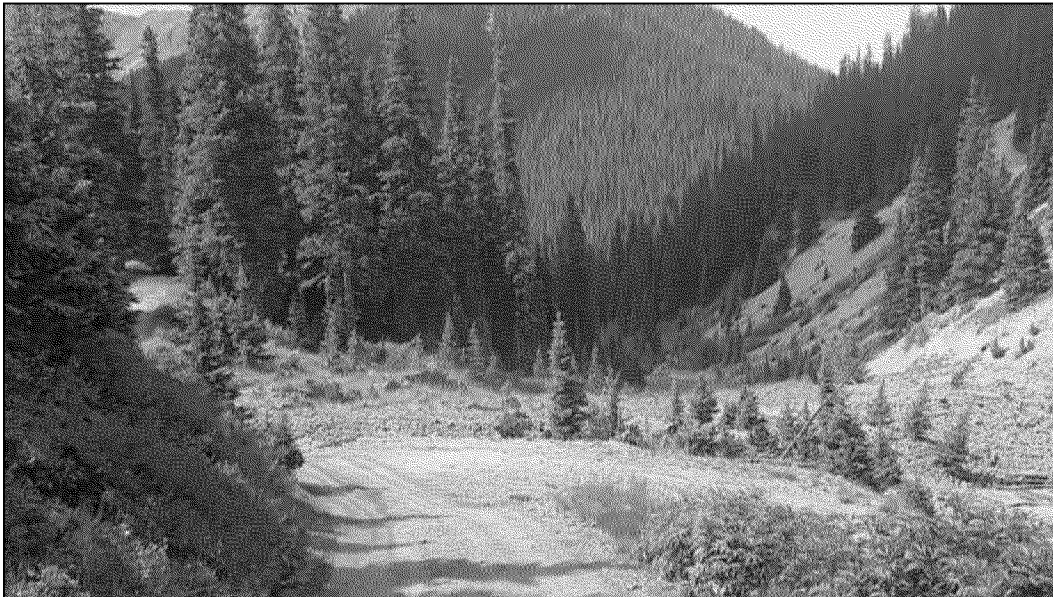
Figure 58.—Photograph looking south along the lower road and Cement Creek showing the blowout flow surging across the lower road and overwhelming Cement Creek (still frame extracted from a video taken on August 5, 2015, at approximately 11:00 a.m.).

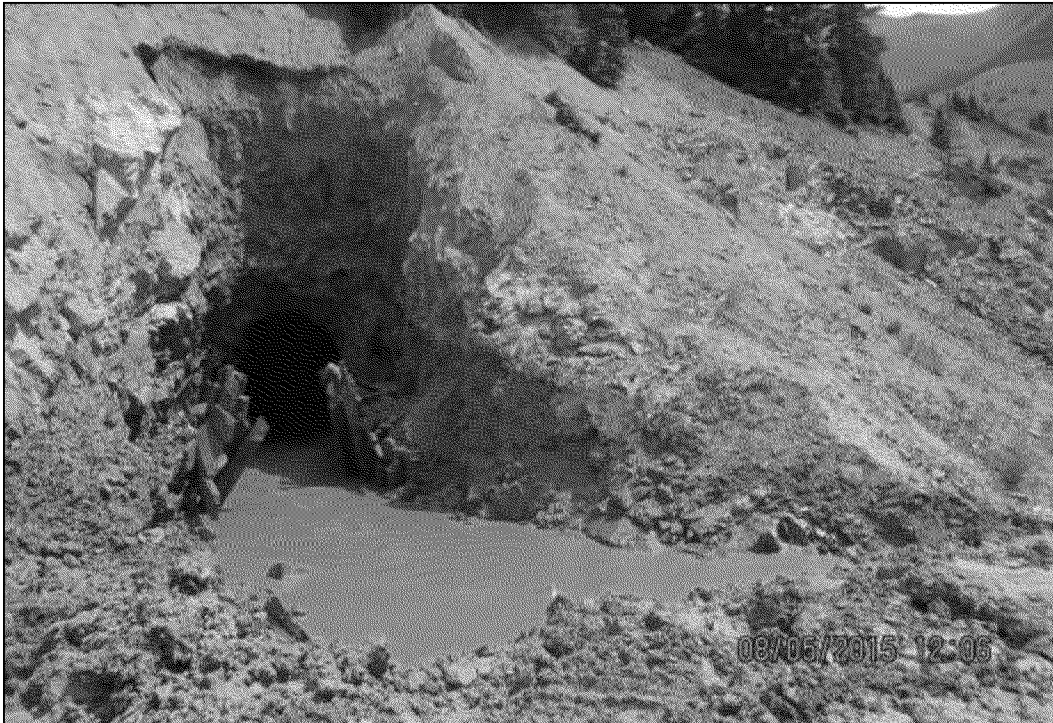
Figure 60.—Photograph showing that the flow had been routed back toward the half-round pipe by 12:06 p.m. on August 5, 2015 (photograph from EPA Project Files).

EPA called down for the roads to be blocked where the stream crosses them, which was promptly accomplished. They also had word passed on to people in Silverton. The details of the notifications made are not a subject of this report. At the site, the top of the waste-rock dump surface was repaired, and the flow was directed back into the remaining bit of the concrete trough and half-round pipe (figure 60). With this accomplished, all but one person left the site by walking down the mountain. One person stayed behind for a few hours to monitor the adit for additional outbursts.

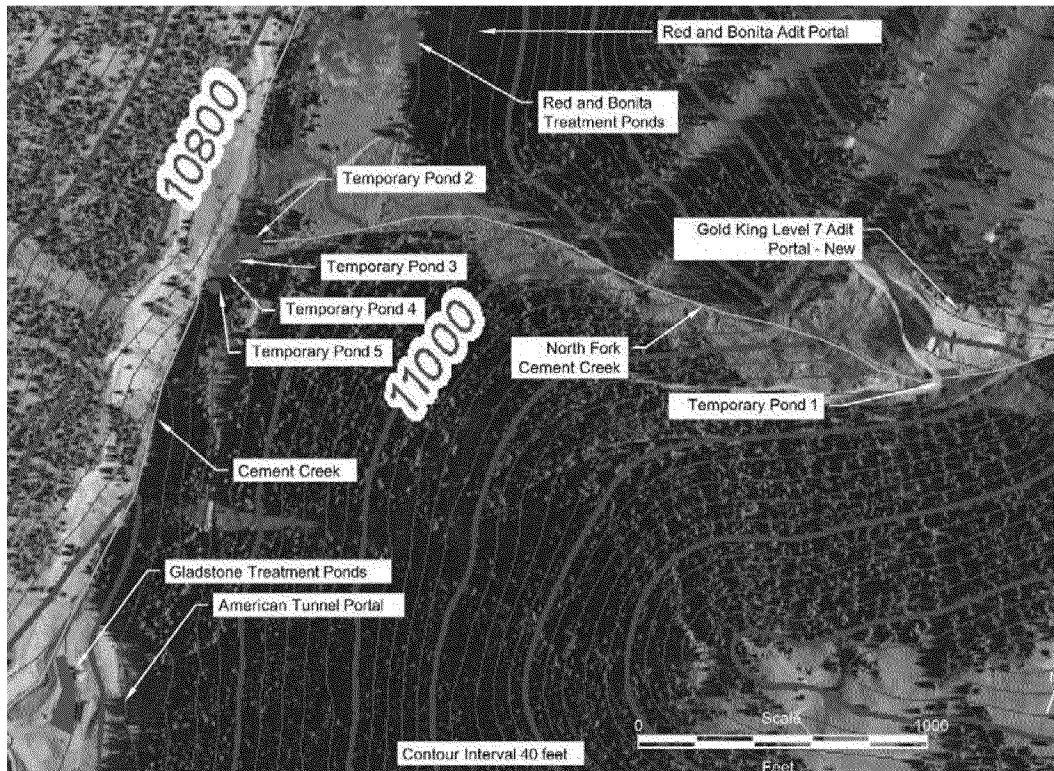
Figure 61.—Illustration showing the location of the temporary treatment ponds that were placed on the North Fork of Cement Creek after the incident.

After notifications were initiated, work began on road repair to reestablish access to the site. This work continued into mid-September. Most of the debris had been deposited in Cement Creek near the confluence with the North Fork of Cement Creek. The debris was removed. Temporary water treatment ponds were constructed on the North Fork using the debris (figure 61). The ponds were immediately put into operation.

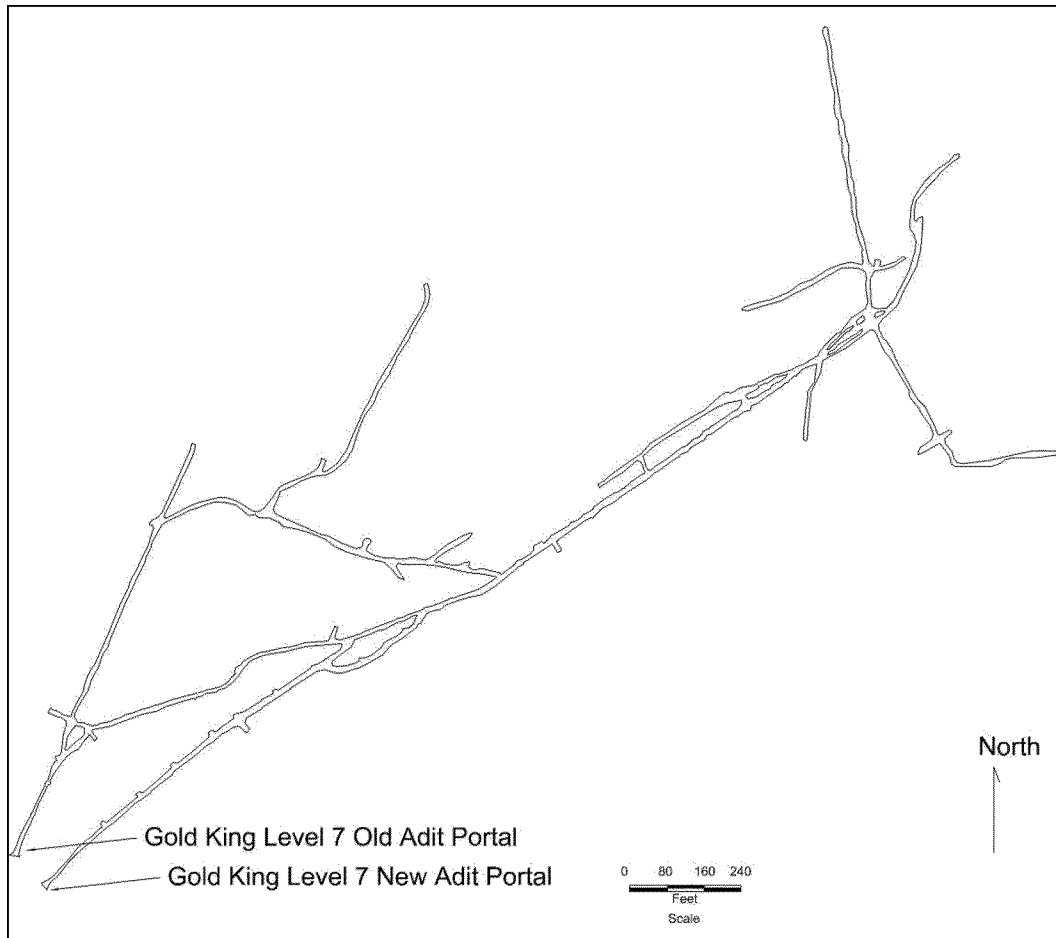
More importantly, because of the gently inclined slope of the new adit to provide drainage, even if the 3 million gallons did not completely fill Level 7 of the mine, it would have completely filled the mine portal area under pressure. The floor of the adit 1,000 feet back in the mine is 10 feet higher than it is at the mine entrance. Even if the water was only 1 foot deep there, the pressure against the portal blockage would have been equivalent to 11 feet of water. The Level 7 adit is estimated to be approximately 2,400 feet long, and therefore it can reasonably be assumed that the water pressure at the portal was significantly higher than that resulting from the water being simply full to the roof at the portal.

Figure 66.—Map showing the extent of the Gold King Mine Level 7 underground workings.

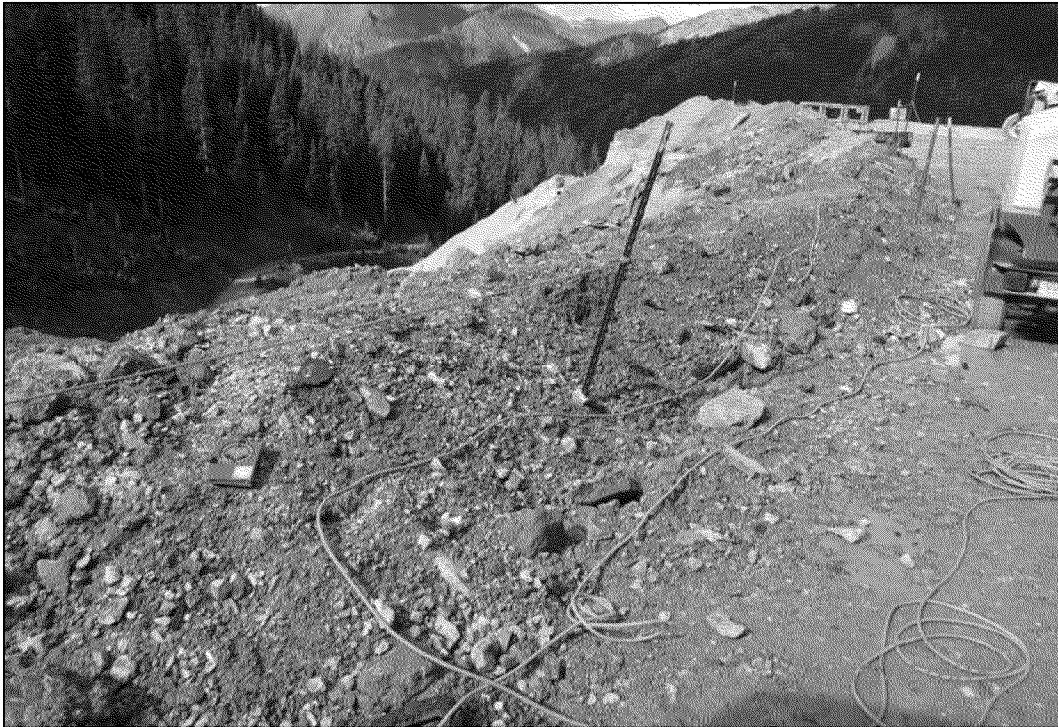
Two samples of the soil from the site were tested (appendix C). Both samples were classified as GC (clayey gravel with sand) with PI (plastic index) values of 13 and 14. Two samples of the clayey gravel were tested for permeability with results of  $3.6 \times 10^{-3}$  cm/s and  $3.4 \times 10^{-4}$  cm/s. This material is not free draining with respect to the observed seepage quantities

Figure C-1.—Photograph showing the safety berm made of soil that was excavated from in front of the Gold King Mine Level 7 New Adit portal. Sample No. 1 consisted of soil sampled from various locations along the safety berm.

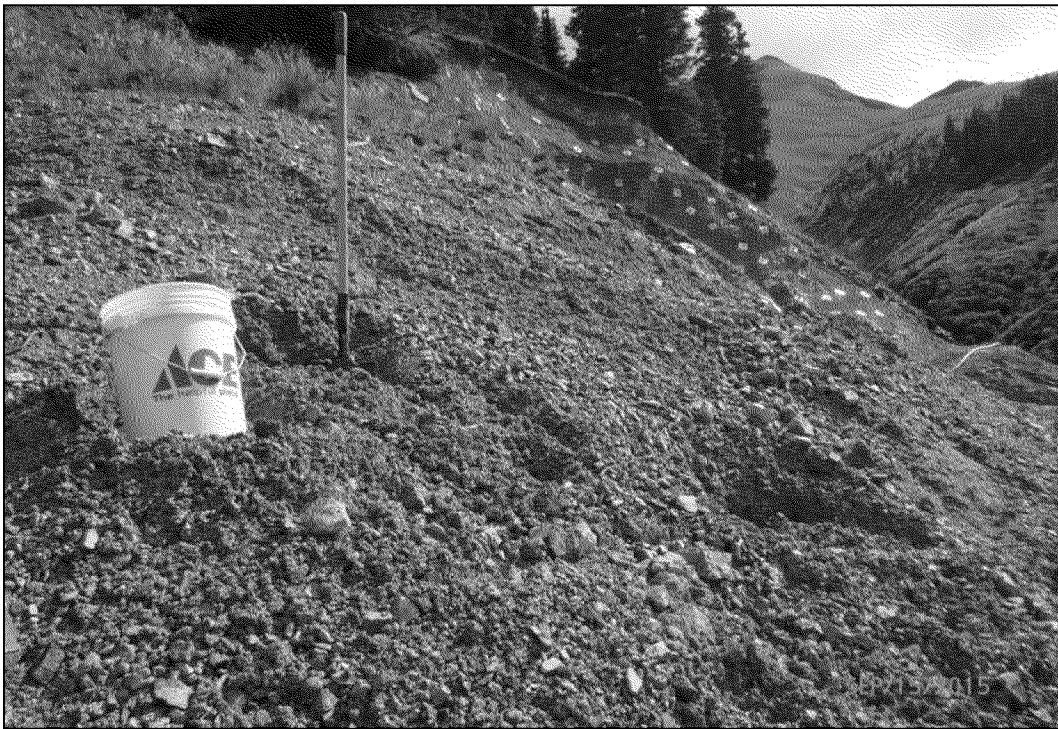
Figure C-2.—Photograph of stockpile where Sample No. 2 was collected. The rock anchors supporting the Gold King Mine Level 7 portal can be seen in the background.
